PROFESSIONAL REAL ESTATE INSPECTIONS

HOME INSPECTION REPORT

1234 SOME STREET
SOMEWHERE, CA

REPORT # 99999999

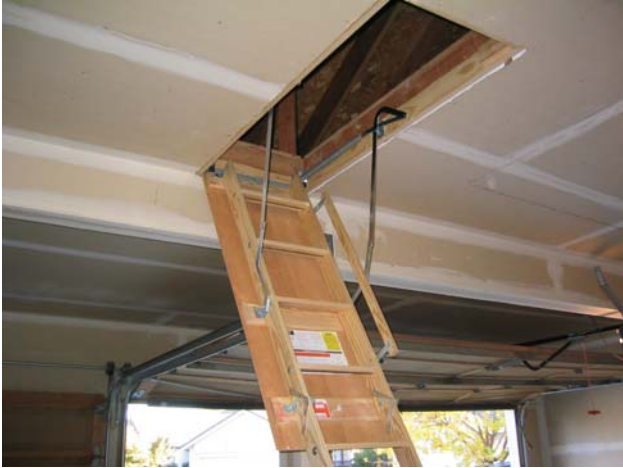
Photo # 2

UNSAT [333] GARAGE FIREWALL CONDITION:(5/8" type X, Sealed)
* Holes/voids above doorbell transformer and lower
 left side of water heater violate firewall - REPAIR,
 NO DRAFTS OR NON-ONE-HOUR-FIRE-RATED-MATERIALS
 ALLOWED. Pull-down ladder in ceiling also violates
 firewall, as no provisions were made to protect
 attic area over garage - REPAIR. (See photos #2 & 3)

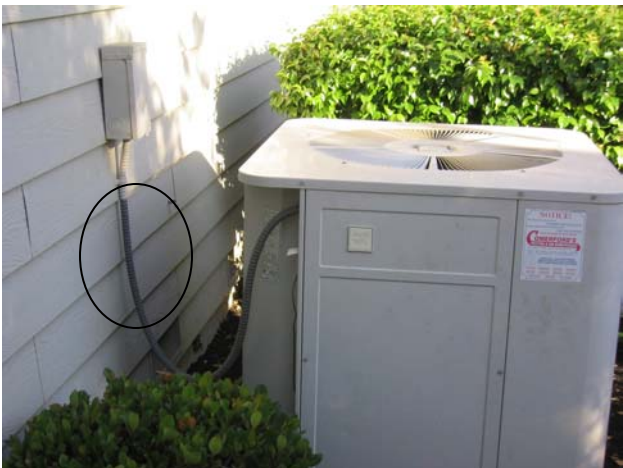
Photo # 4

UNSAT [389] LEFT SIDE EXTERIOR ELECTRICAL:
 * A/C electrical cable is not secured to wall adjacent
 to disconnect box - REPAIR. (See photo #4)

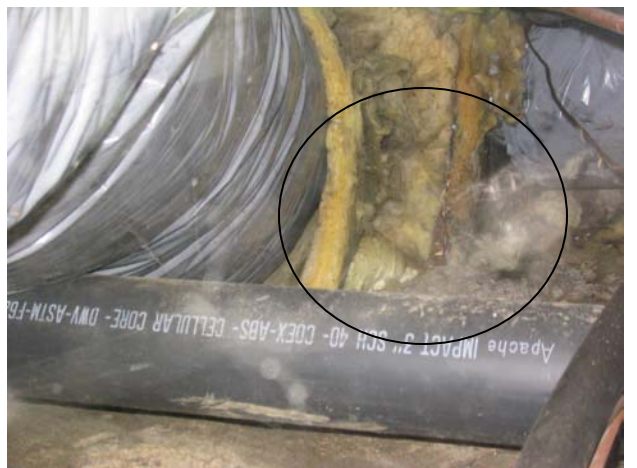
Photo # 5

UNSAT [476] UNDER-FLOOR FURNACE PLENUM AND DUCT CONDITION:
* Some ducts are in contact with soil or have less
 than 4" clearance to soil - REPAIR. Furnace plenum
 is also in contact with soil (see photo #5), and
 soil is damp around plenum, indicating a possible
 internal leak at the condensate line. Recommend
 further investigation by an expert in this field.
 Also, dryer vent is disconnected - REPAIR.
